Final Report
STUDY THERMOGRAPHIC FLAW DETECTION

Contract Number: NAS8-38609

July, 1996

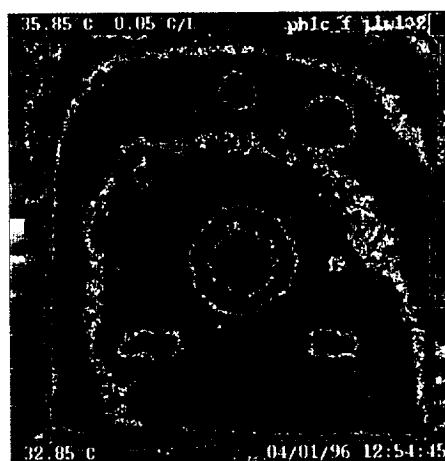
Figure 9. Image before and after digital filter.

Using digital filtering techniques an attempt to enhance the back surface heated image was made by applying the Winfree (Laplacian) filter and several self developed filters. The Laplacian filter was unable to resolve the thermal profile of the part. On the other hand a simple “edge enhancement” filter proved to be very useful by defining the shapes of each planned defect (Figure 9). The filter consisted of a 7 x 7 array in the form shown in Table 2.

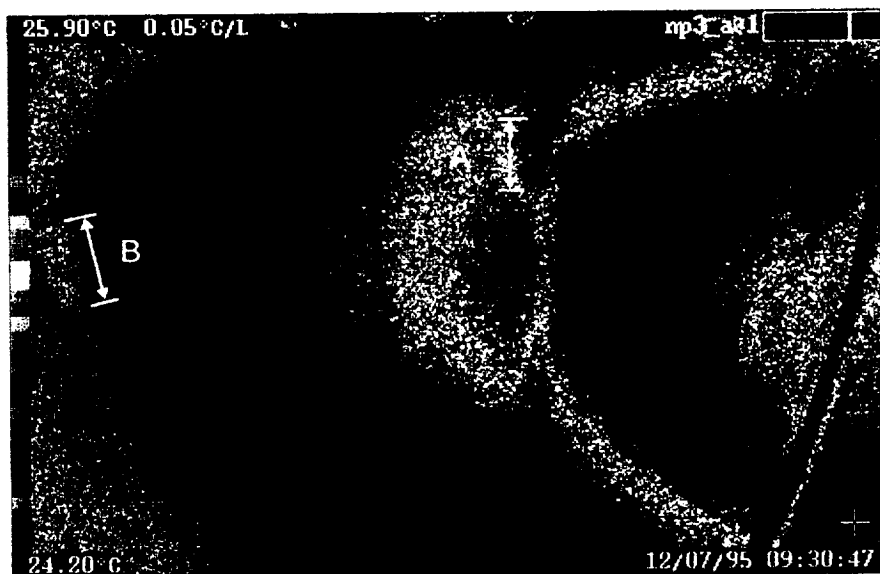
Figure 35. NPU-3, Pass A, Flaws A and B.

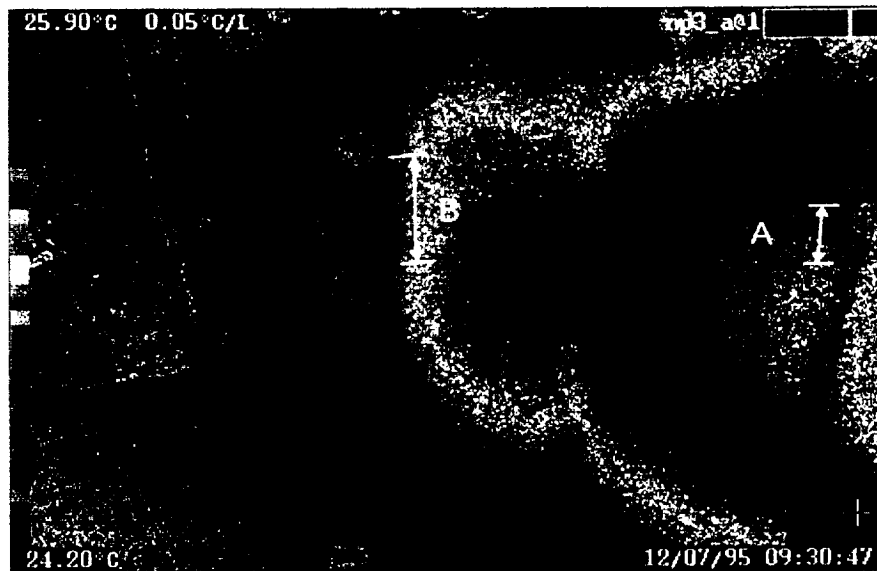
Figure 37. NPU-3, Pass A, Flaws B and A.

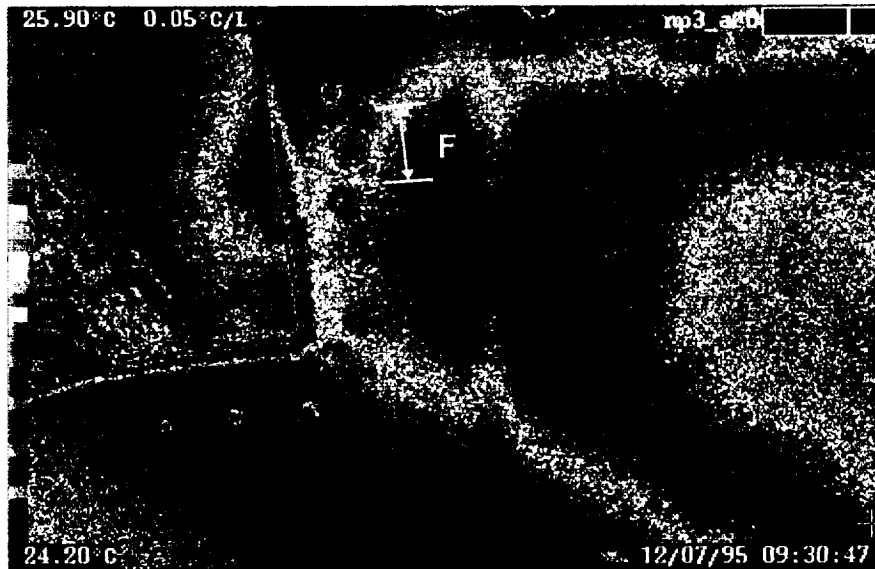
Figure 43. NPU-3, Pass A, Flaw F.

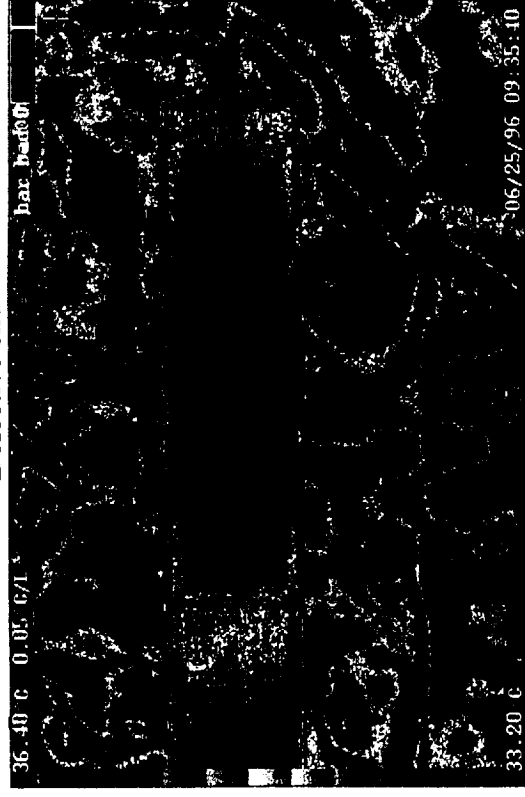
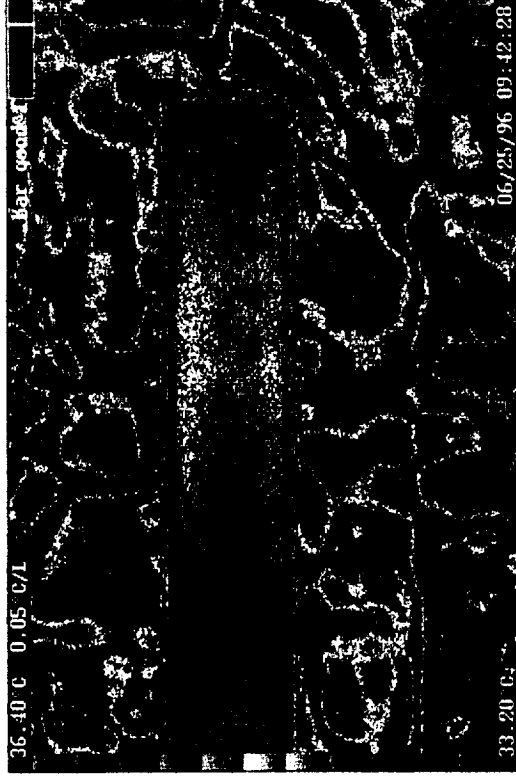
Figure 68 Thermograms of graphite/epoxy spar..

Defective end

Good end
